**BUILDING CONDITION ASSESSMENT REPORT**

Public Works Facilities  
Davie Street  
Quesnel, BC

Prepared For: City of Quesnel

File 18-109

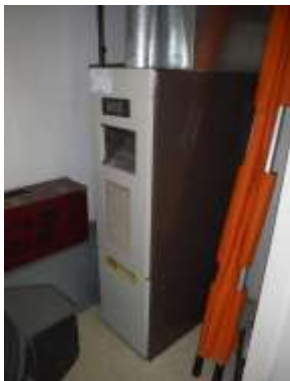
Figure 1 First Aid Station Mechanical

The mechanical system is old, and there does not appear to be a fresh air intake. A downdraft would cause a potential health risk (carbon monoxide).

***In the short term, some maintenance is required to ensure there is no life safety or health risks to the staff. Not recommended to engage any upgrading of services or finishes as the expenditure would not be justified.***

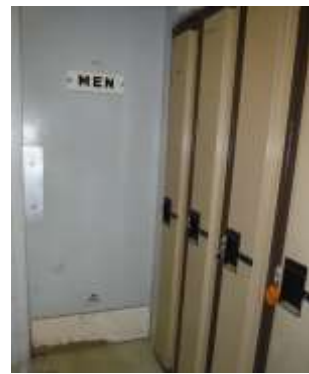
Figure 7 Mens Washroom Access

Access to the washroom does not meet code requirements. The door width access is reduced with lockers placed right next to the door opening. There are two lavatories, one urinal and two water closets. The ventilation system may not be in proper working condition.

***Presently, the washrooms are functional and maintenance would be required in the short term. No expenditures are recommended as the washroom would require major renovations to accommodate the current building code for access and barrier free provisions.***

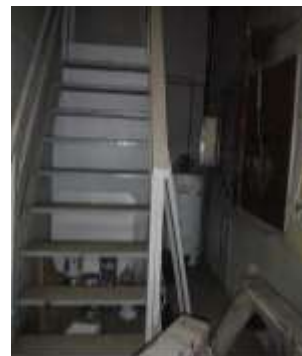
Figure 17 Mezzanine Stair

There are no man doors to outside off the two bays. The only door leads back into the washroom and lunchroom areas. The mens and ladies washrooms have poor access. The staircase leading to the small mezzanine office is unsafe.

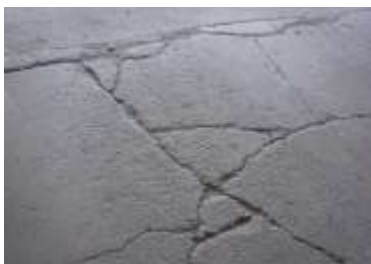
Figure 32 Slab Cracking

The age of the structure, modifications and additions over time has impacted the structural integrity that may cause future issues. While the steel members appear to be relatively good condition, the wood frame components have shown signs of aging. The storage shed roof is structurally inadequate to withstand the roof snow load. The floor slab in the main service area has experienced severe cracking and surface deterioration. Any upgrades or changes will be costly; all surfaces and finishes may contain hazardous materials that would require abatement procedures.

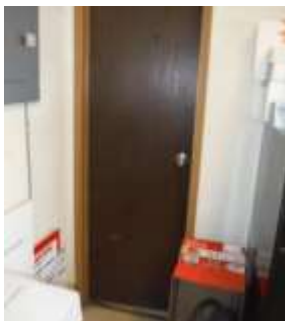
Figure 41 Washroom Door

The furnace is located next to the main entrance and has no fire separation to the space. It is very old and past its usefulness. All interior finishes are well worn. The washroom is very small and the door access is only 2'-0" wide.

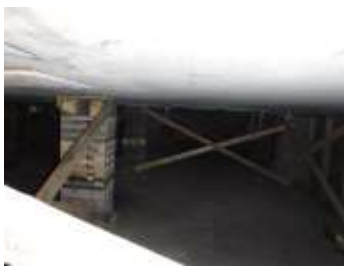
*Figure 47 Wood Cribbing/Cross Bracing*

The bouncy floor indicates that the floor joists are not in good structural condition. The joists may have certain degree of decay or other types of damage. Also, the cribbing foundation does not provide adequate lateral stability to the building against the design wind and seismic loads.

In terms of life expectancy, the building is not likely to last much longer. Upgrading is not recommended at this time. However, if there are plans to continue to use this building, a maintenance and safety plan should be implemented in the short term. In addition, any upgrades or renovations might require a hazardous materials assessment.

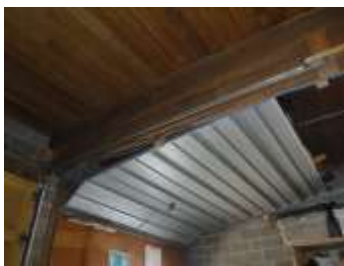
Figure 52 Glulam Beam

The roof structure consists of wood planking supported on 5¼" x 27½" glulam beams. The glulam beams span the entire width of the building and are supported on concrete block pilasters. There is no available information indicating whether the block walls are reinforced. However, judging from the age of the building, it is reasonable to assume that the walls are not adequately reinforced for a seismic event.

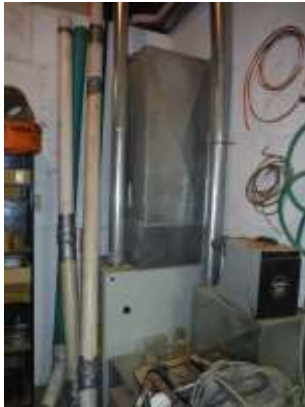
Figure 56 Furnace in Warehouse

The furnace for the offices and lunchroom is located in the stores warehouse. The walls that separate the warehouse from the offices are frame and are not fire separations. The overall building is in fair condition, although minimal upgrades have been done.

Upgrading is not recommended at this time. If there are plans to continue to use this building short term, and inspection and upgrade of the mechanical system as well as addressing safety and health concerns would be required.

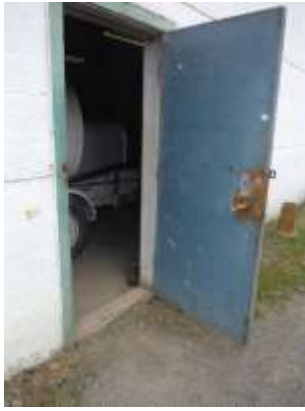
Figure 65 Entrance Door

The roof is showing significant sagging, showing its inability to withstand the snow load. The building does not have a proper lateral support system to provide adequate lateral stability to resist wind and seismic induced loading, and the tall built-up roof further reduces the overall stability of the building. It appears that a fire had occurred in one compartment and may have damaged the structure in that space.

It is not recommended that this building use be continued for anything at this time. The roof is disintegrating and there is general concern about safety. The current uses for this space should be move to another location.

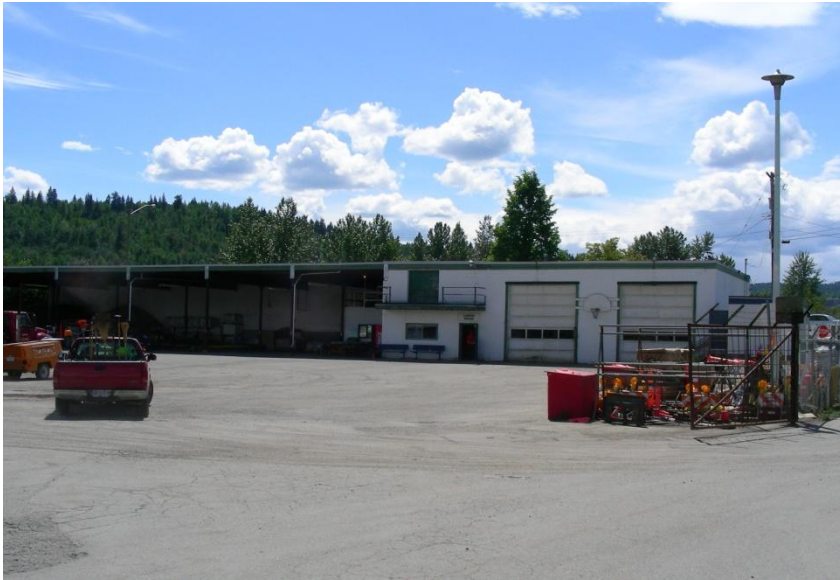
Roof is approximately 15+ years old but its still in satisfactory condition. Some minor buckles. . Chimney cap to replace. No cap stripping on the perimeter. No roof leaks have been reported. Front canopy membrane is shot. Should probably be replaced or torn down. Life expectancy with minor repairs 7-10+ years.

Covered parking and Lunch Room building. SBS membrane

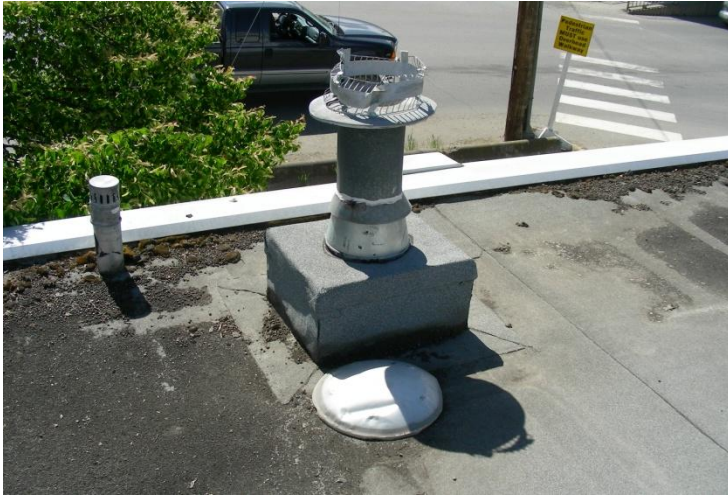
Chimney cap missing. North end

1. Roofs #2,3b,7a , 8 need to be refastened with screws.( pull out nail replace with metal roofing screw)( Or retighten existing screw)
2. Roof # 4 re-caulk T laps in 5 years time.
3. Roof # 1 Replace chimney cap and one storm collar
4. Roof 1 front canopy replace or remove.

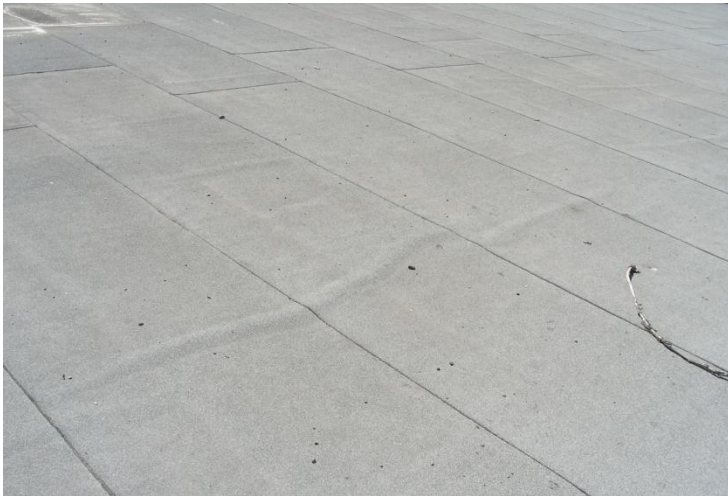
Minor ridging all sections.

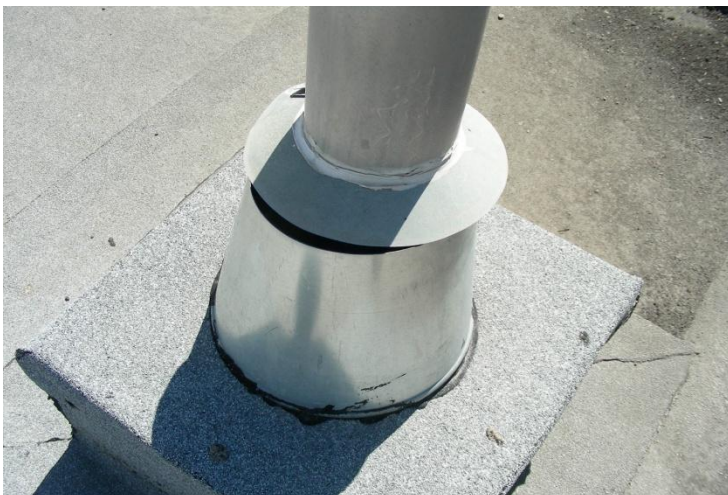
Chimney storm collar does not cover oversized tall cone flashing. Leaking ?

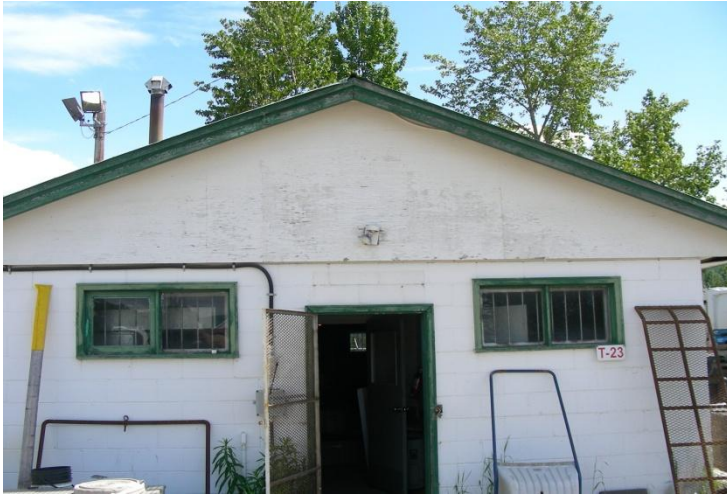
Heated storage/ workshop building Roof #2 nails popping out.

Roof is approximately 20+ years old but its still in fair condition. See Photos. Nails are popping out. Refasten all nails with metal roofing screws. No roof leaks have been reported. Caulk and re-fasten chimney. **Life expectancy 10 years +**

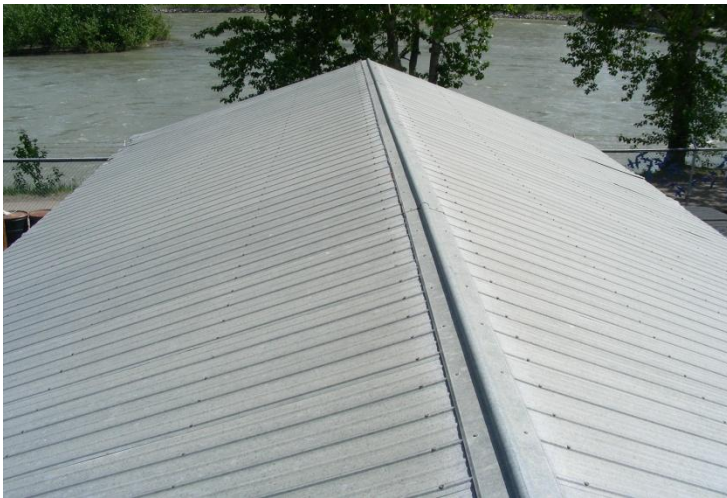
Minor damage to metal panels on the Southwest side. Replace nails with metal roofing screws.

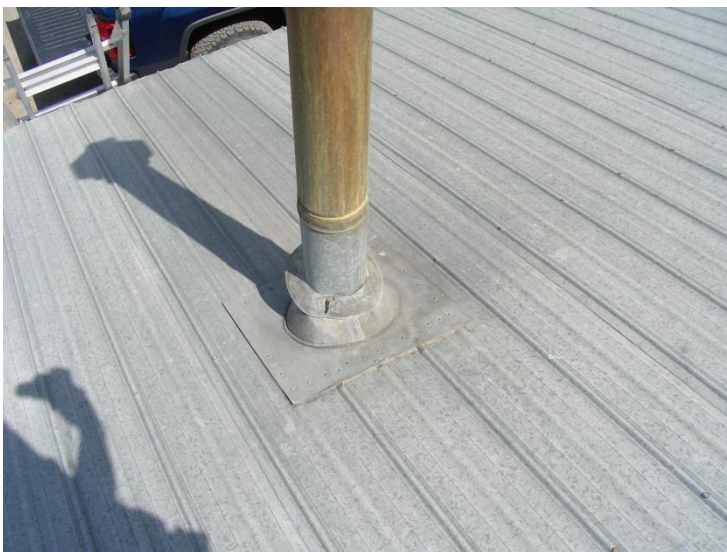
Chimney flashing not installed properly . Re-screw and caulk.

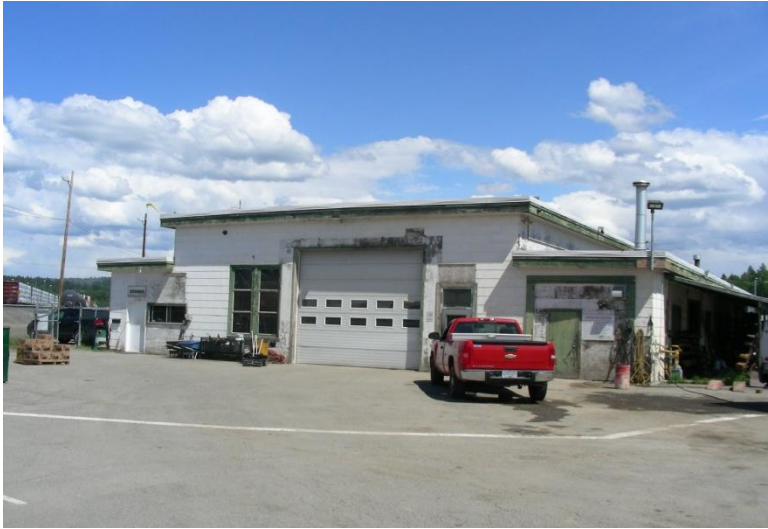
Roof #3a , shop/store. Roof is old and leaks reported.

Roof is very 30 years old + Roof is in poor condition. Leaks have been reported. **Life expectancy 1-2 years-**

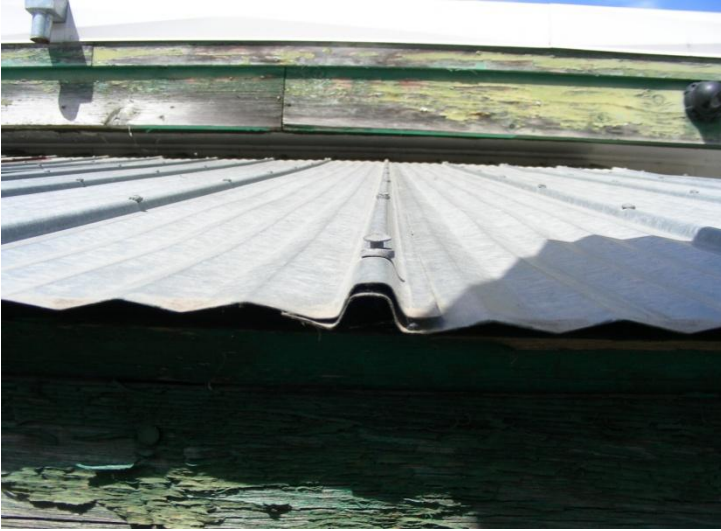
Roof #3b Replace nails on 3b with screws.

Roof is approximately 20+ years old but its still in fair condition. See Photos. No roof leaks have been reported. Refasten all nails with metal roofing screws. **Life expectancy 10 years +**

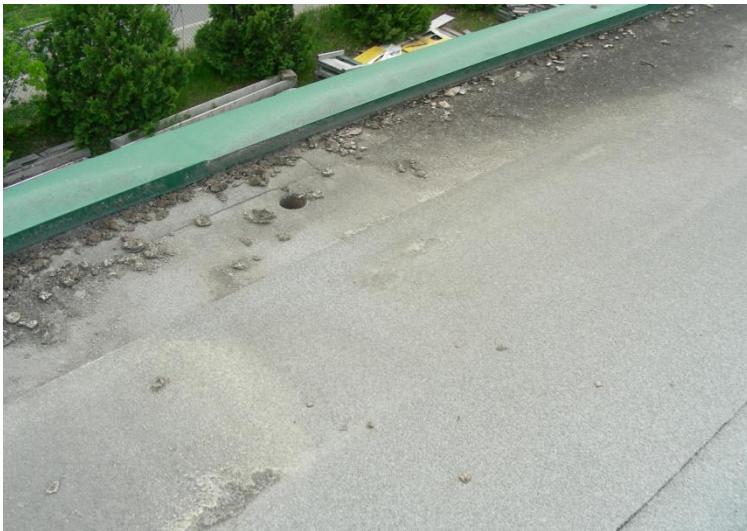
Roof 4 b overview .Looking west.  
Flat drains no strainers.

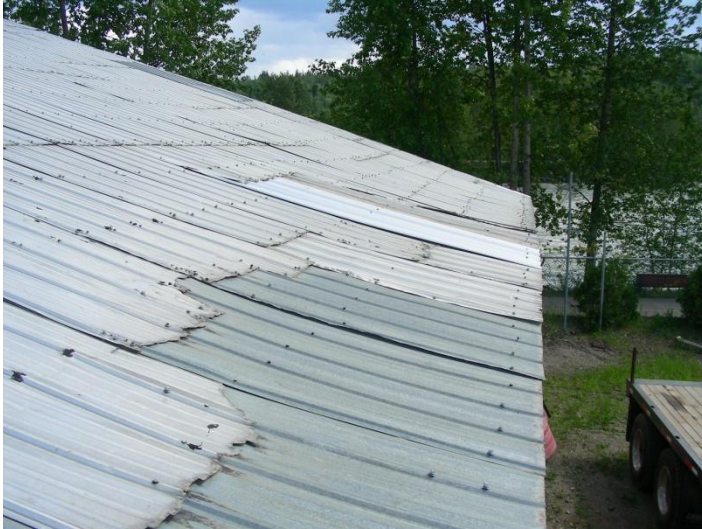
Roof 6A overview .Looking south.  
Nails popping alot of damage  
holes and repairs

Roof is approximately 30 + years old. It has been repaired extensively. Roof is in failed condition. See Photos. Nails are popping out. There are hole in the metal everywhere. Nails have to be taken out and replaced with screws. No roof leaks have been reported. We suspect multiple roofs underneath this one. **Life expectancy 0 years** +

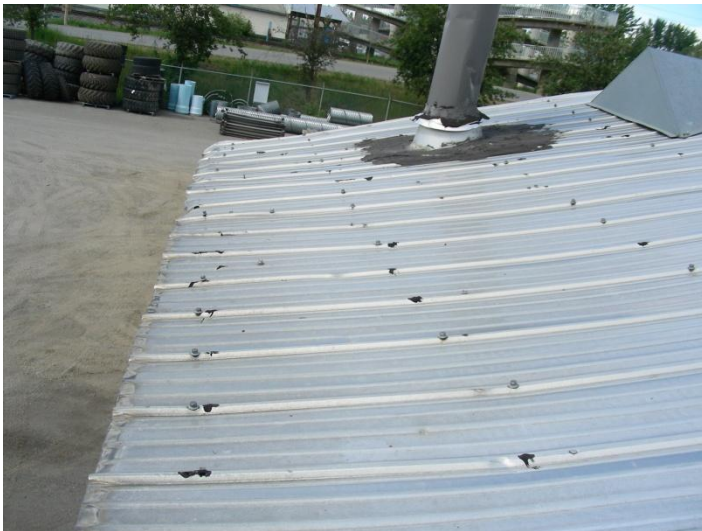
Roof 6A overview .Looking North  
Nails popping deck swaled back  
near the perimeter.

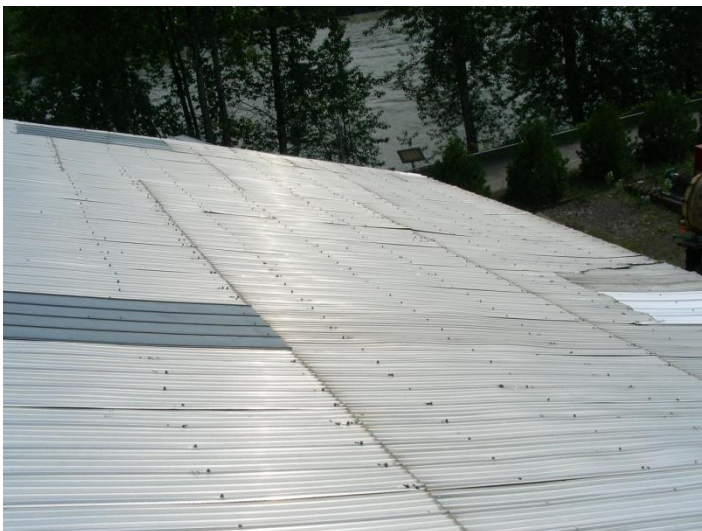
Roof 6A overview .Looking South  
Alot of damage and makeshift  
repairs .

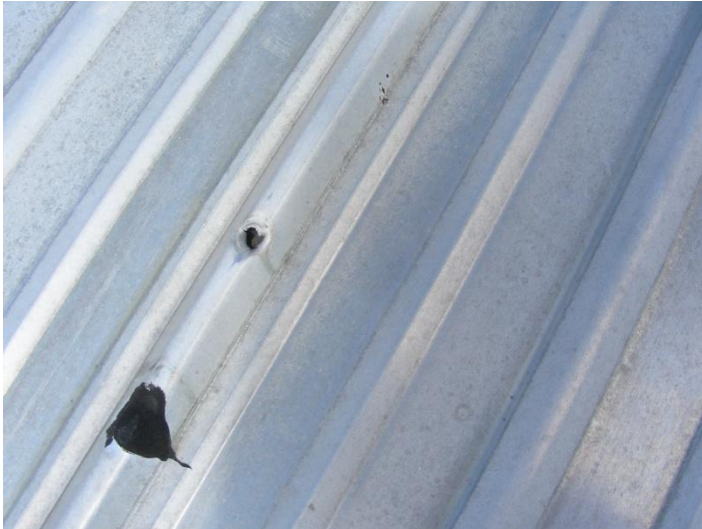
Roof 6A holes and damage everywhere.

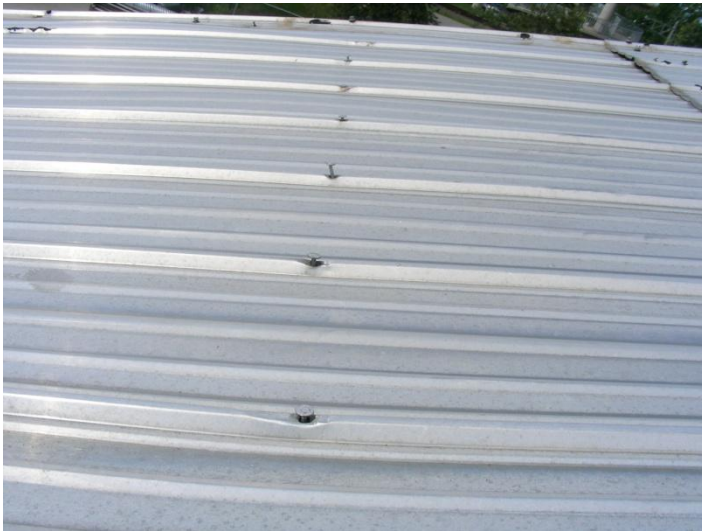
Roof 6A popped nails

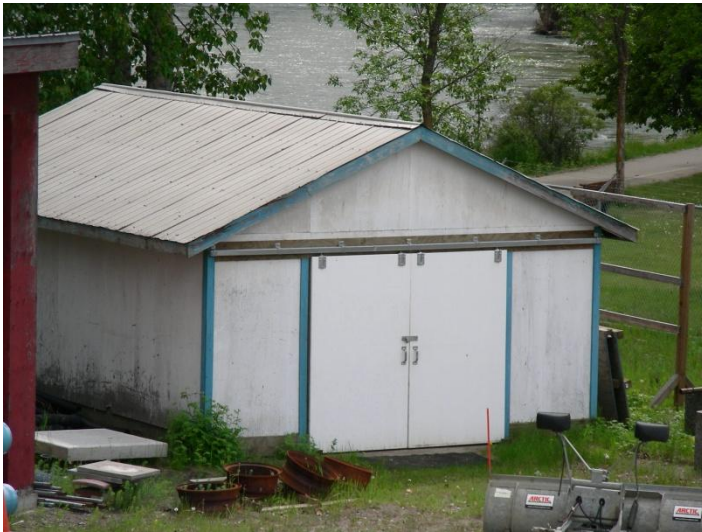
Fencing shed Roof 8 overview .  
Fair condition.

Roof is in fair condition. Fascia is rotten Some screws backing out and nails popping. but 1/12 is too low slope for metal. **Life expectancy 4-7 years** +

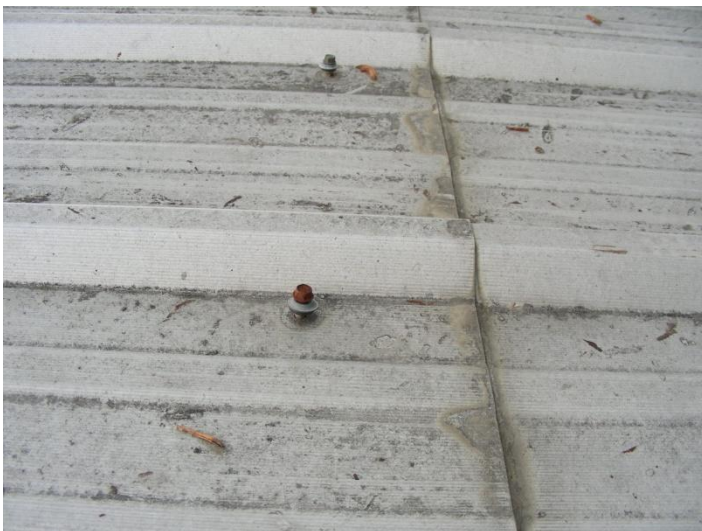
Roof 6b overview .Screws backing  
out..
