**RFP 505 PANORAMA RIDGE DEMOLITION AND REMEDIATION ADDENDUM #1**

# Pre-Demolition Hazardous Materials Survey Report

505 Panorama Ridge, Quesnel, BC

Apex File Number: COQU25-001

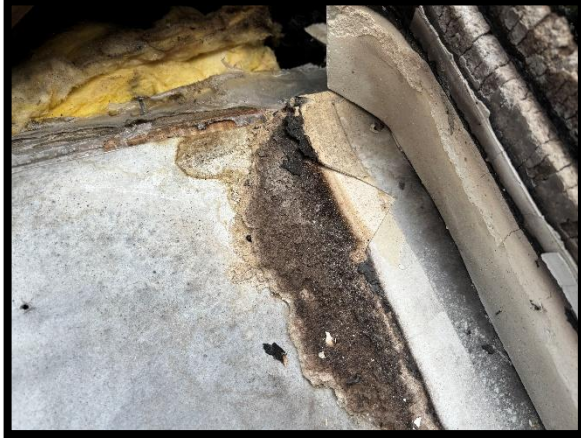
Asbestos was not identified within the drywall joint compound (S01) present as debris within the Debris Pile (Loc. 1).

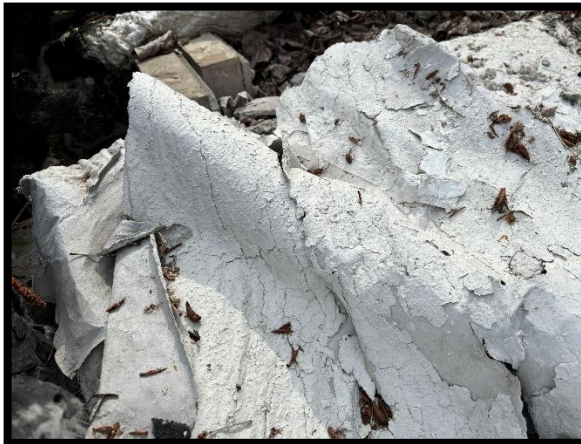
Asbestos was not identified within the texture coat (S02) present as debris within the Debris Pile (Loc. 1).

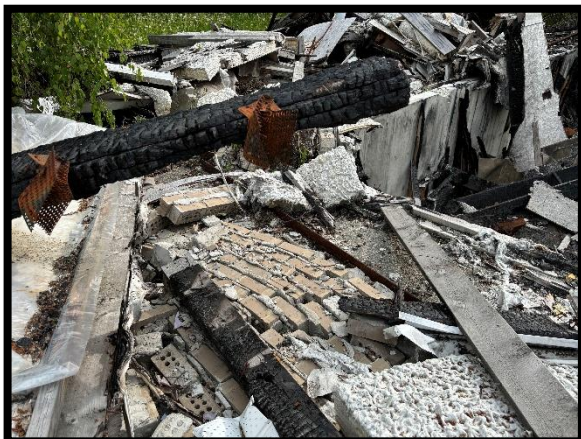
Asbestos was not identified within the brick mortar (S03) applied to bricks and present as debris within the Debris Pile (Loc. 1).

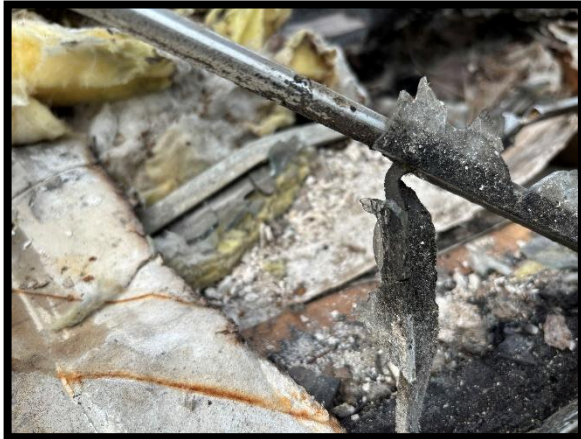
Asbestos was identified within the grey window mastic (S04) applied to windows within the Debris Pile (Loc. 1).

- Due to the presence of asbestos-containing window mastic debris, the Debris Pile (Loc. 1) should be treated as an asbestos-contaminated environment. Entry into the debris pile should be limited to workers following moderate risk asbestos work procedures (1/2 face respirator with p-100 filters, Tyvek suit, rubber boots, wash-up station). All porous contents should be disposed of as asbestos waste. Non-porous contents may be decontaminated by wet wiping and/or HEPA vacuuming following asbestos work procedures.

- All asbestos-containing material must be removed using safe work procedures and practices prior to/ in conjunction with demolition activities.
- An asbestos risk assessment must be performed by a qualified professional prior to demolition work occurring to determine the exposure risk to workers and other persons.

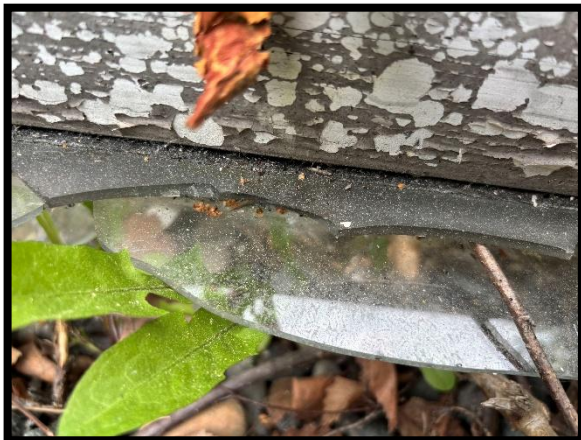
Asbestos was identified within the black window mastic (S05) applied to windows within the Debris Pile (Loc. 1).

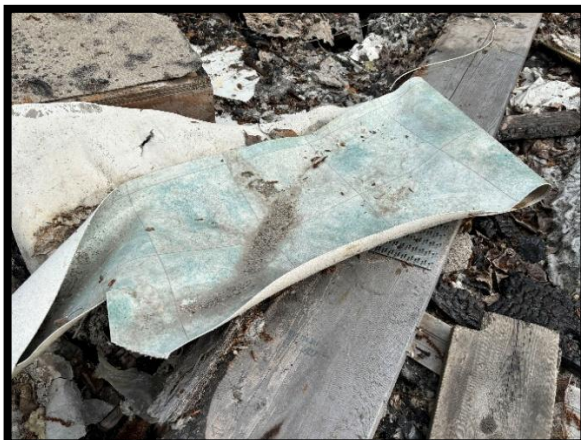
Asbestos was not identified within the blue and white pattern vinyl sheet flooring (S06) present as debris within the Debris Pile (Loc. 1).

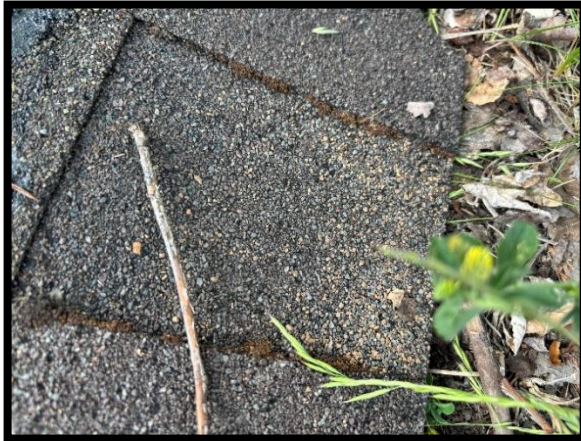
Asbestos was not identified within the brown and black asphalt shingles (S07) present as debris within the Debris Pile (Loc. 1) and present on the roof of the Shed (Loc. 2).

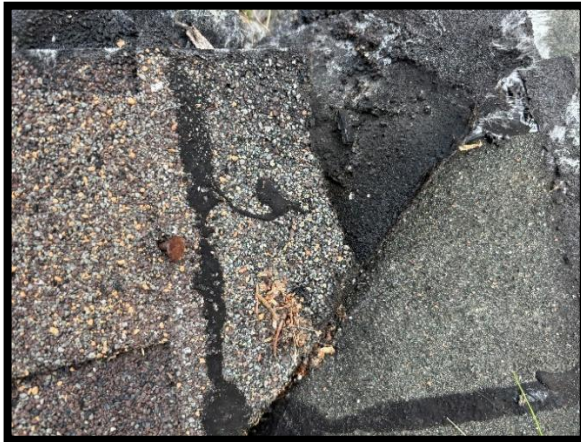
Asbestos was not identified within the grey and black asphalt roof shingles (S08) present as debris within the Debris Pile (Loc. 1).

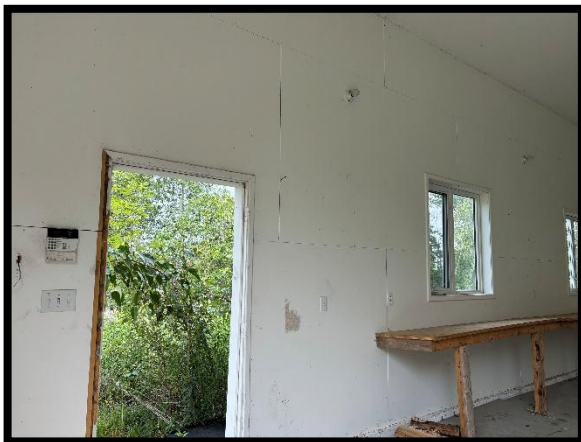
Lead was not identified within the off-white paint (L03) applied to wood panelling within the Shed (Loc. 2).

Lead was not identified within the white paint (L03) applied to wood trim within the Shed (Loc. 2).
