Pre-Demolition Hazardous Materials Investigation Of 21 Johnston Bridge Loop, Quesnel, BC

Prepared for

City of Quesnel 410 Kinchant St Quesnel, BC V2J 7J5

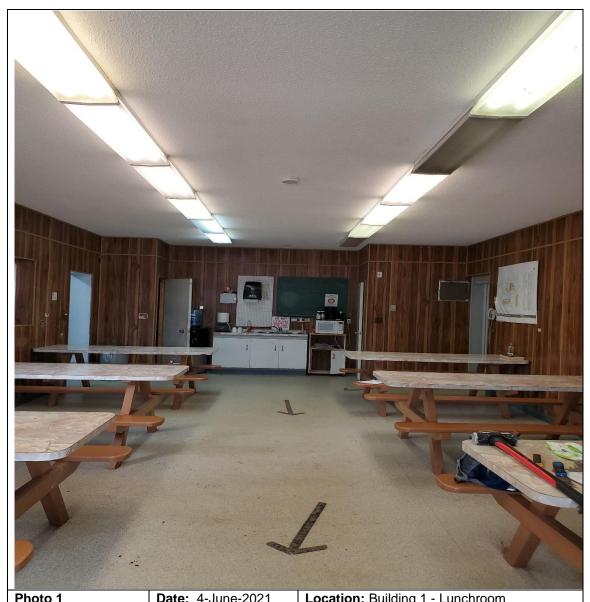
Photo 1 Date: 4-June-2021 Location: Building 1 - Lunchroom

Description: View showing asbestos containing drywall joint compound on the ceiling as well as a smoke detector and fluorescent lights/ballasts

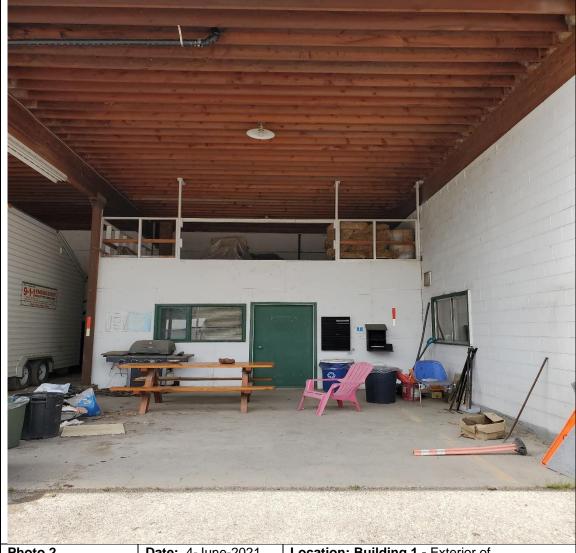
Photo 2 Date: 4-June-2021 Location: Building 1 - Exterior of lunchroom/first aid room

Description: View showing cinderblocks with asbestos containing vermiculite insulation

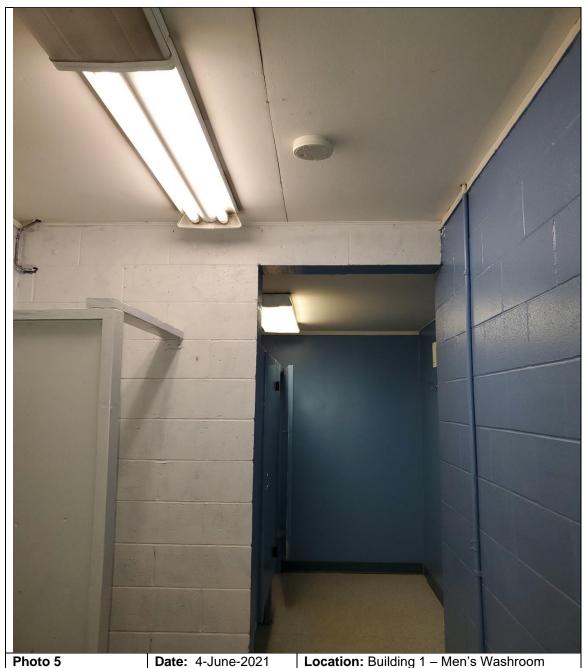
Photo 5 Date: 4-June-2021 Location: Building 1 – Men's Washroom Description: View showing lead containing dark blue paint and smoke detector and fluorescent light tubes and ballast

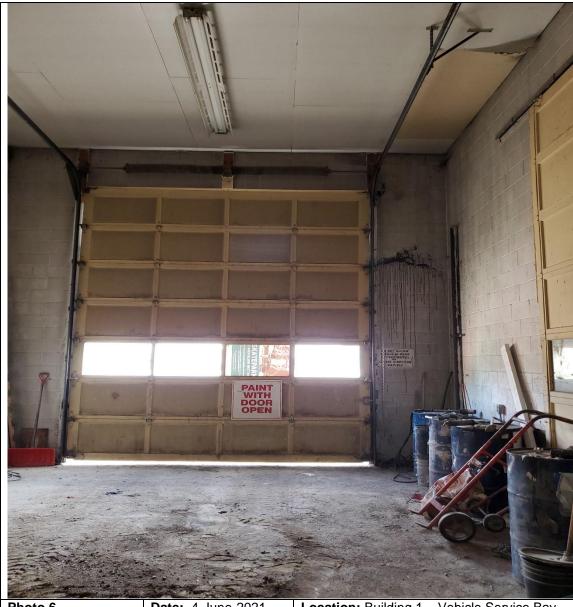
Photo 6 Date: 4-June-2021 Location: Building 1 – Vehicle Service Bay Description: View showing lead containing pale yellow paint and fluorescent lights and ballast
