**Pre-Demolition Hazardous Building Materials Survey
of
325 Lewis Drive, Quesnel, BC**

June 20th, 2025

**Prepared For:
The City of Quesnel**

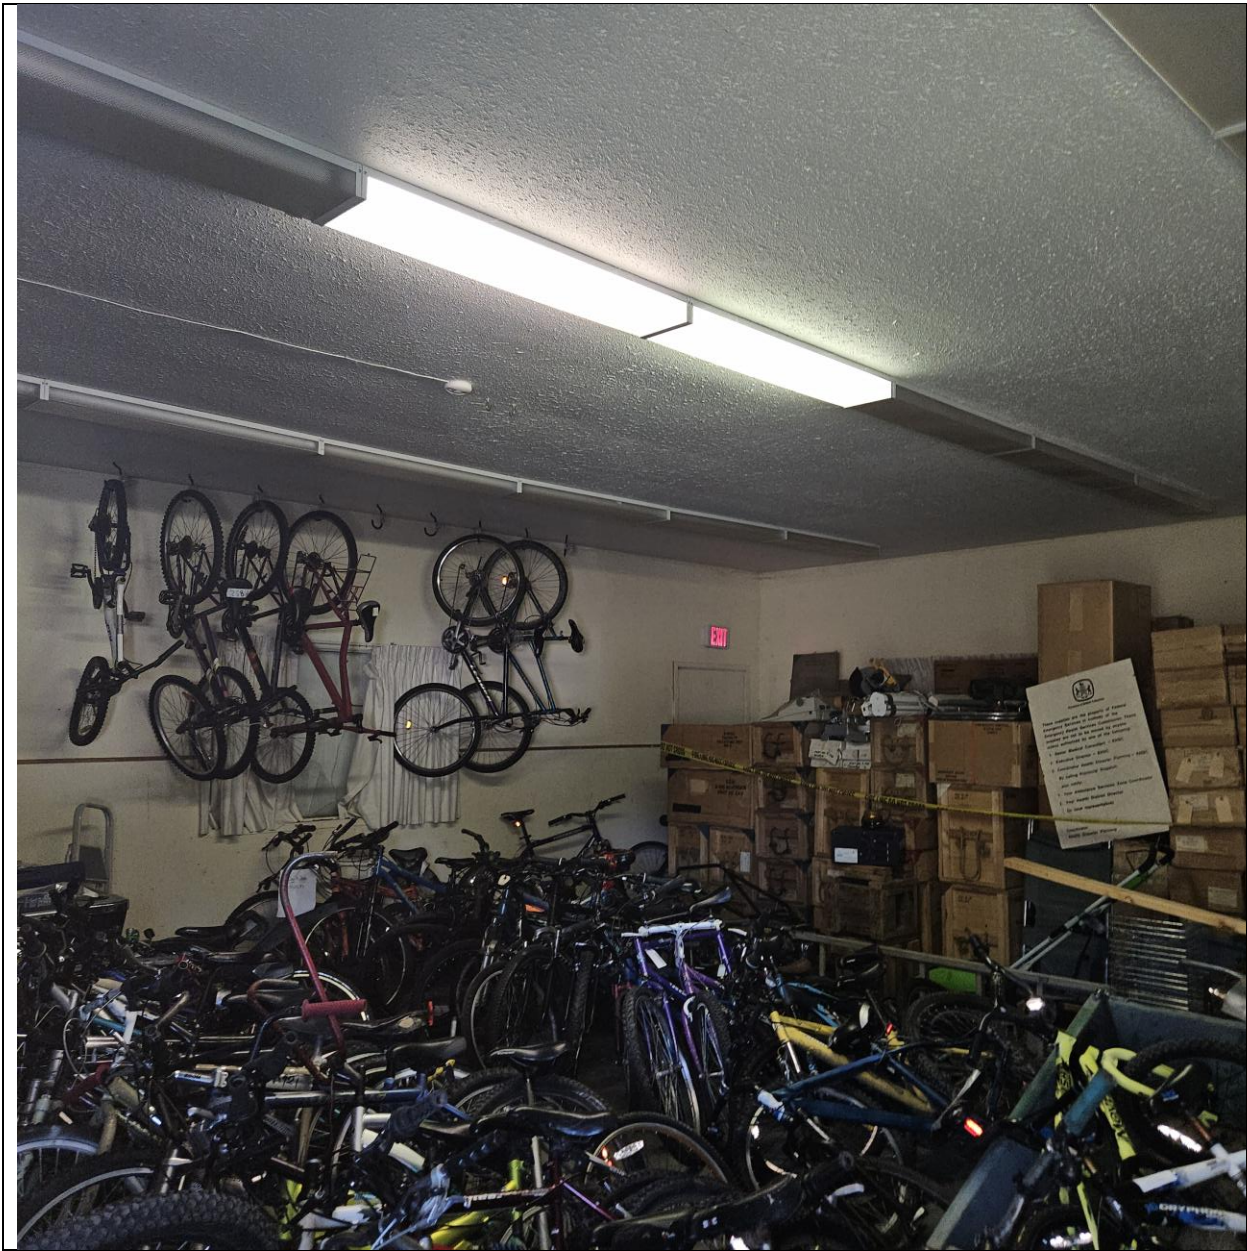
Photo 1	Date: 10-June-2025	Location: Interior
Description: View showing interior of the structure

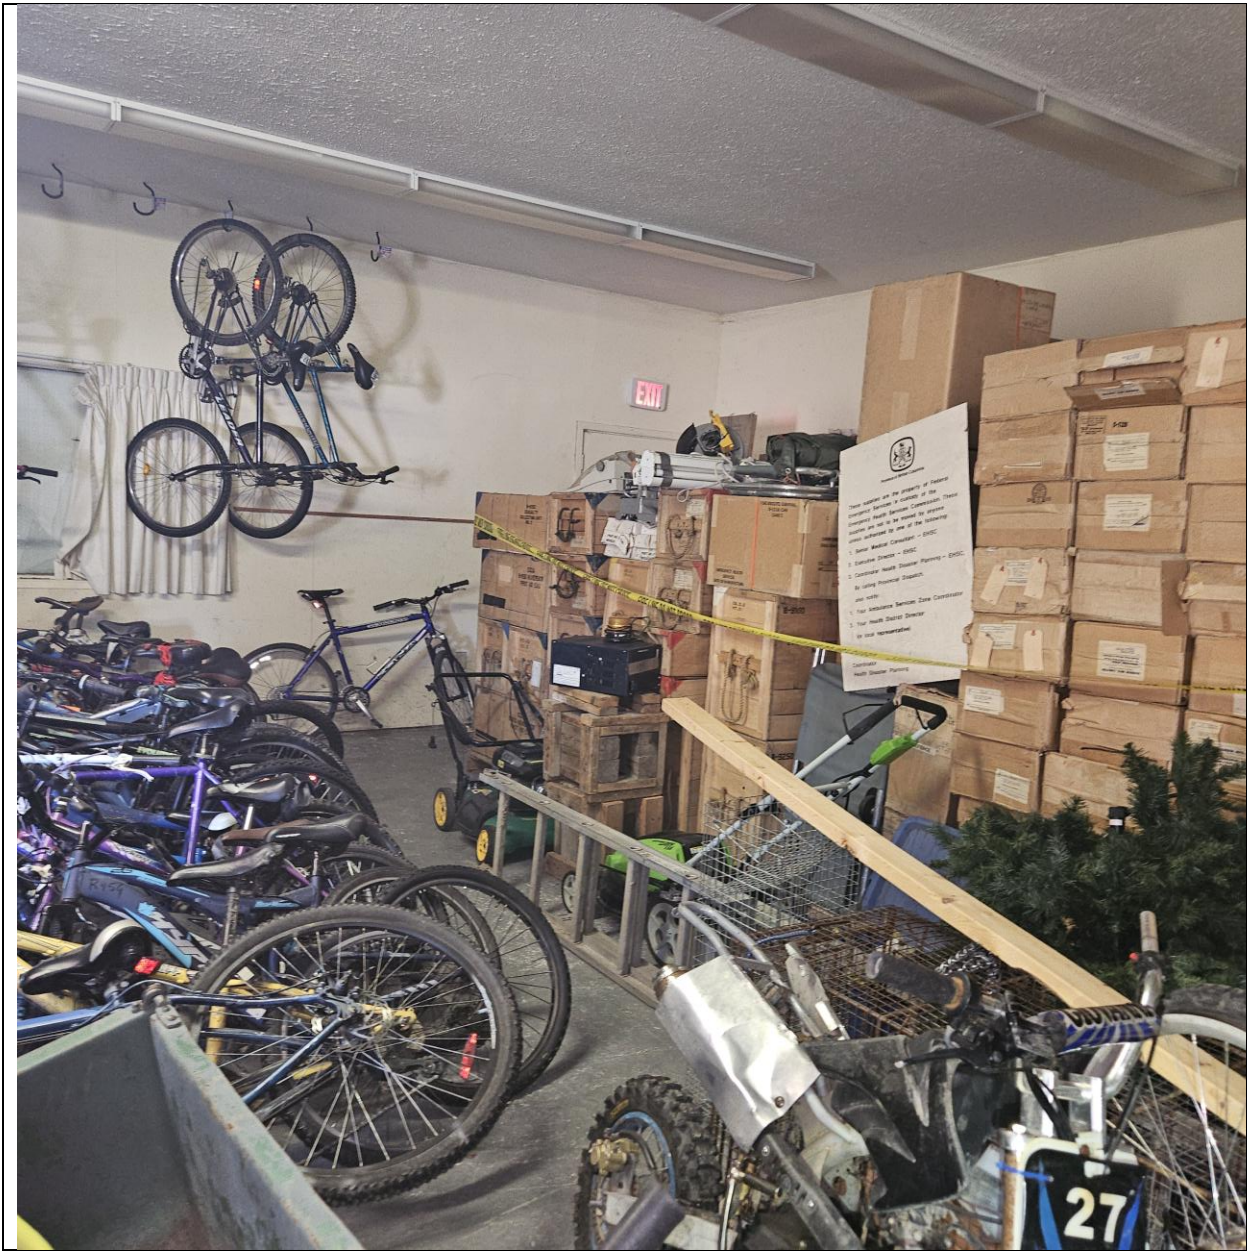
Photo 2	Date: 10-June-2025	Location: Interior
Description: View showing the interior of the structure.
