**WEST QUESNEL LAND STABILITY STUDY
QUESNEL, BRITISH COLUMBIA**

The City of Quesnel
410 Kinchant Street
Quesnel, BC
V2J 7J5

30 October, 2002

KX03904

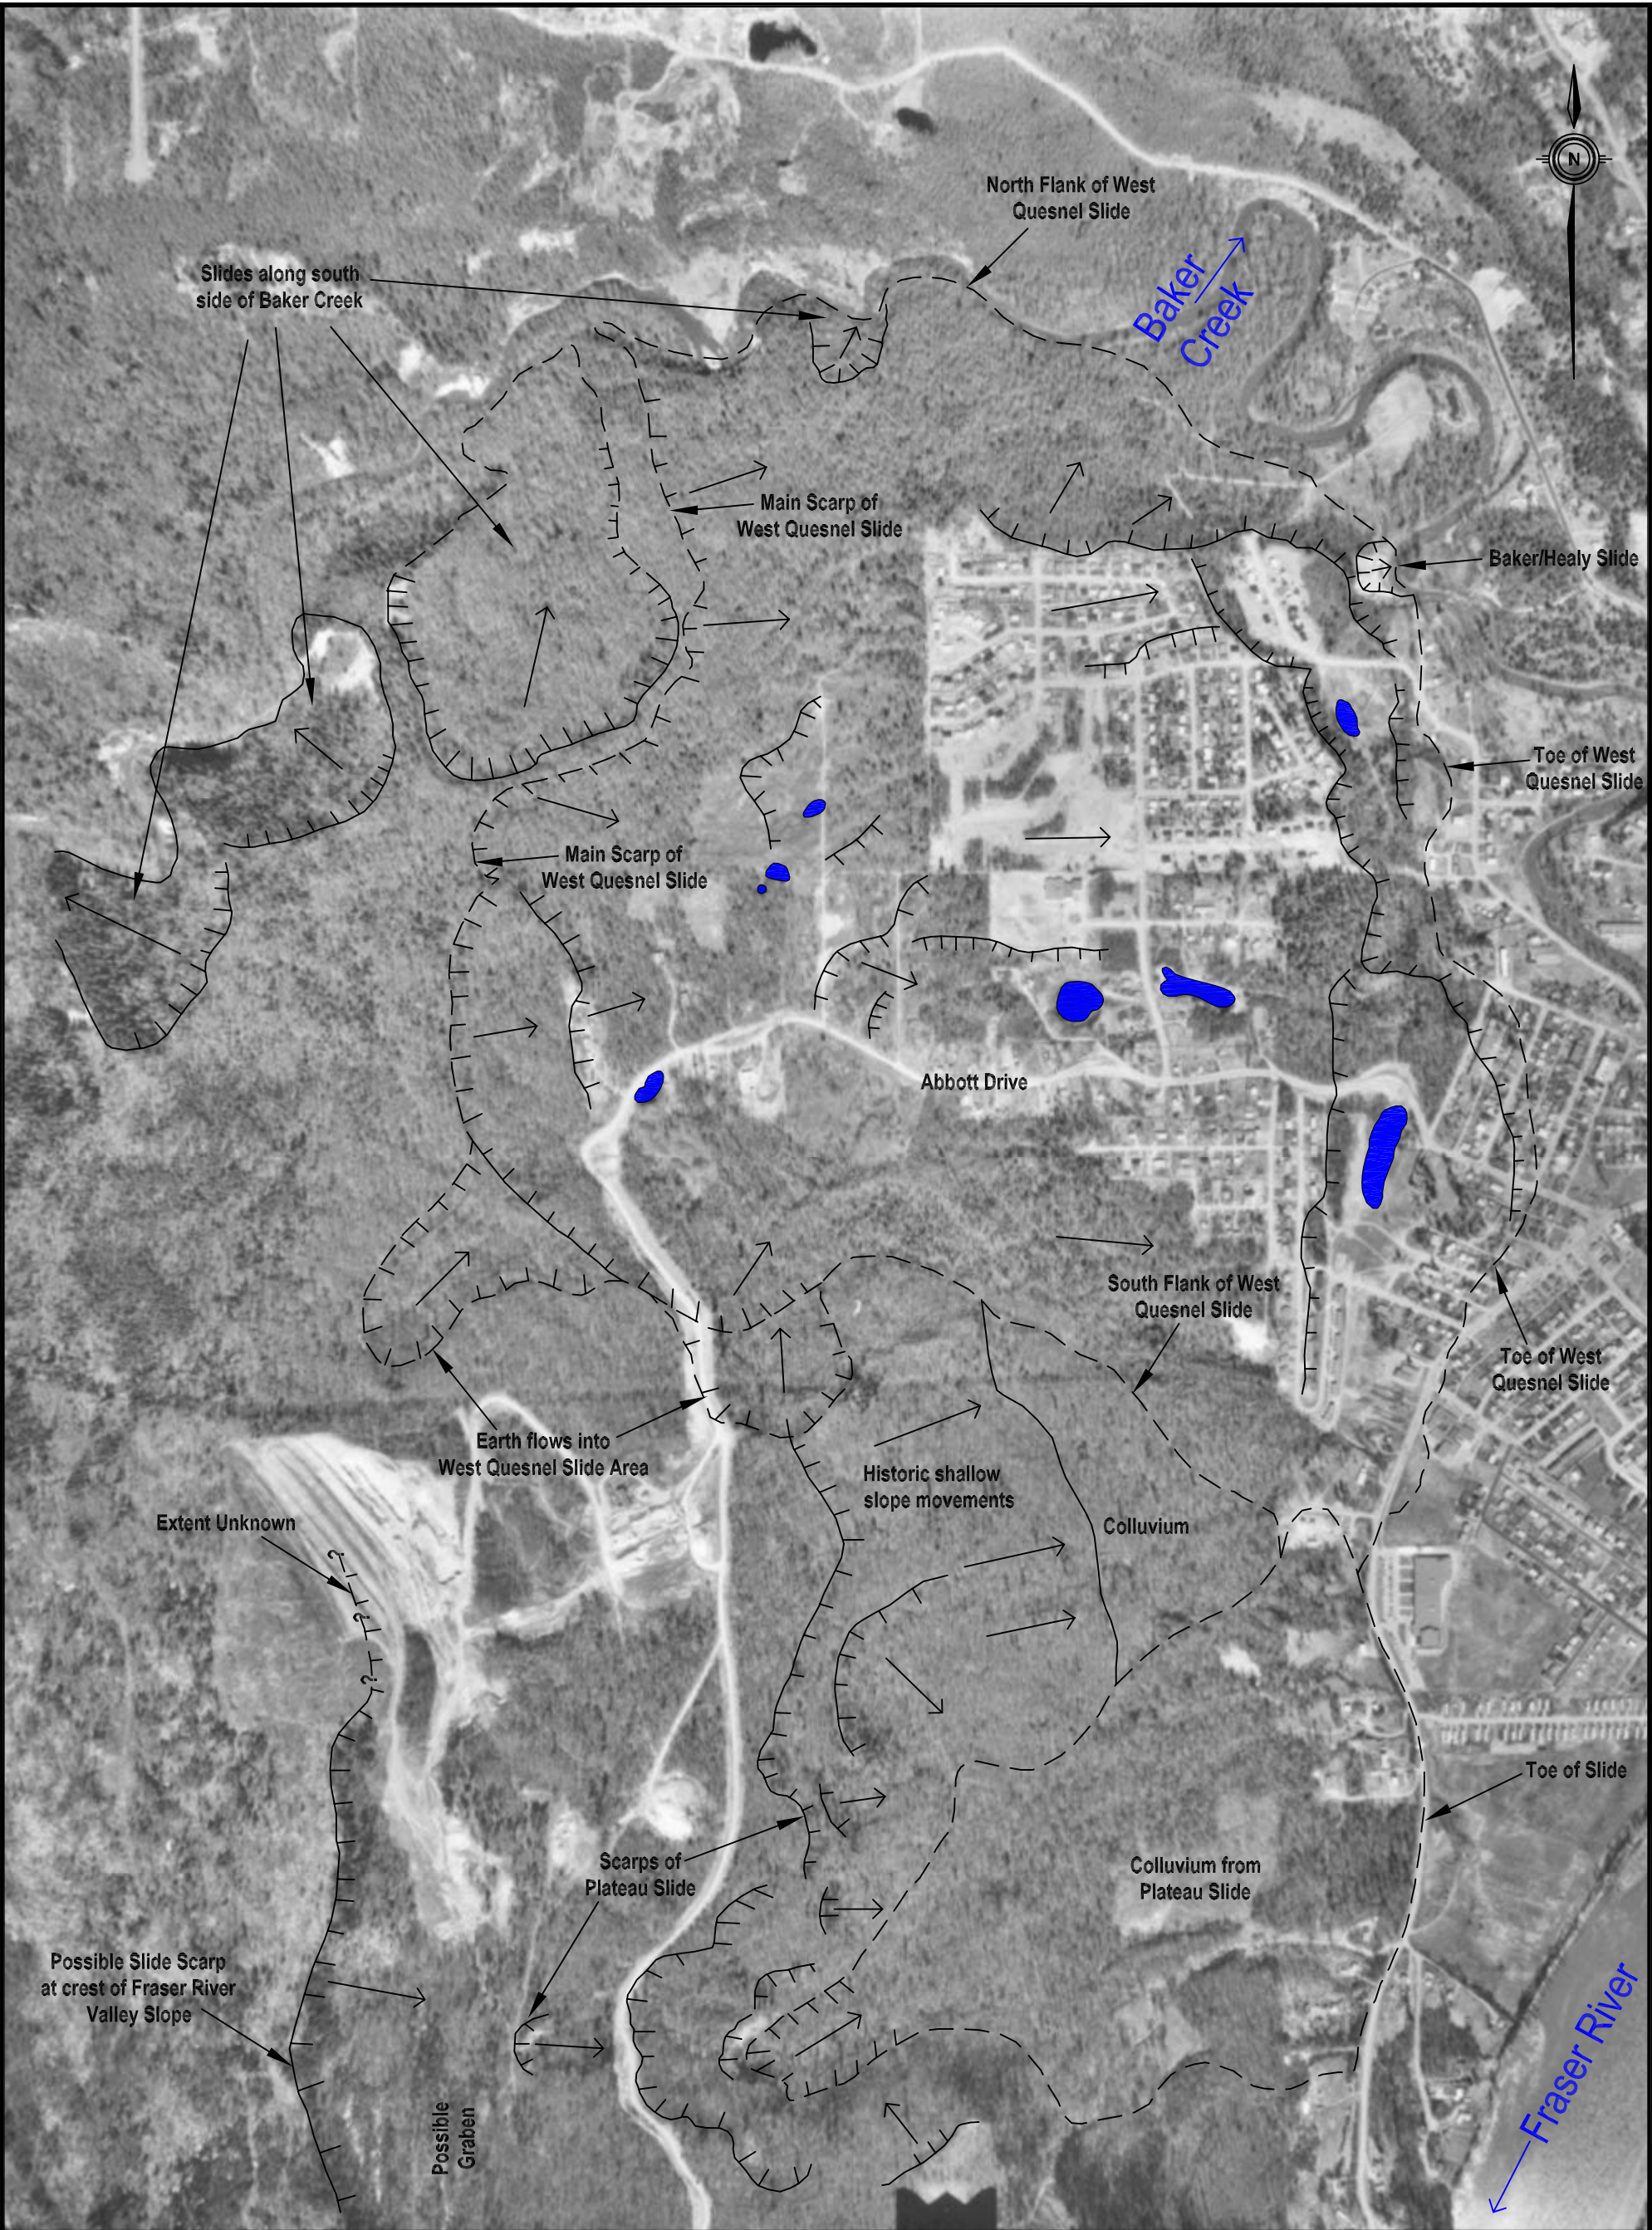
- b) A slide in the northwest portion of the study area adjacent and downstream of the slides discussed (Point a) above. The slide was approximately 450 m wide, 100 m high and 600 m long. The slide appeared to be originally caused by toe erosion when Baker Creek was at a higher level. A weak layer at approximately 20 to 30 m depth and/or excessive groundwater seepage could also be contributing factors. Baker Creek did not appear to be actively eroding the toe of the slide from 1949 to 1997. No evidence of significant movement of these slides was identified on the airphotos taken between 1949 to 1997. Note that small movements or creep would not be detectable from the airphoto interpretation.

- 3) The Plateau Slide was located in the southeastern portion of the study area (as shown in Figure 3 and Figure 5) essentially adjacent to the inferred south flank of the West Quesnel Slide. The main scarps of the Plateau Slide were located on the Fraser River Valley Slopes to the south of the study area (as shown in Figure 5). The Plateau Slide appeared to be a series of retrogressive earth slides that have slid, broken up and flowed onto the Fraser River floodplain. Based on a review of the historic airphotos it appears that there have been some ongoing movements evident in the scarps of the slide since 1949, although there were no indications of any significant earthflows during the past 53 years.

- 5) Within the general Uplands and Erosional Slope area, the terrain appeared to be ridged to hummocky in many areas with areas of ponded water (including the Abbott Drive Pond, Flamingo Street Ponds, Adam Street Pond, two ponds in the Dawson Road area and a pond south of Lewis Drive on a bench in the Erosional Slope). The ridged to hummocky terrain is consistent with a ground surface that has been modified by landslide activity. The ponds noted in the study area could be "sag ponds" where water collects in low areas formed by downdropped slide blocks.

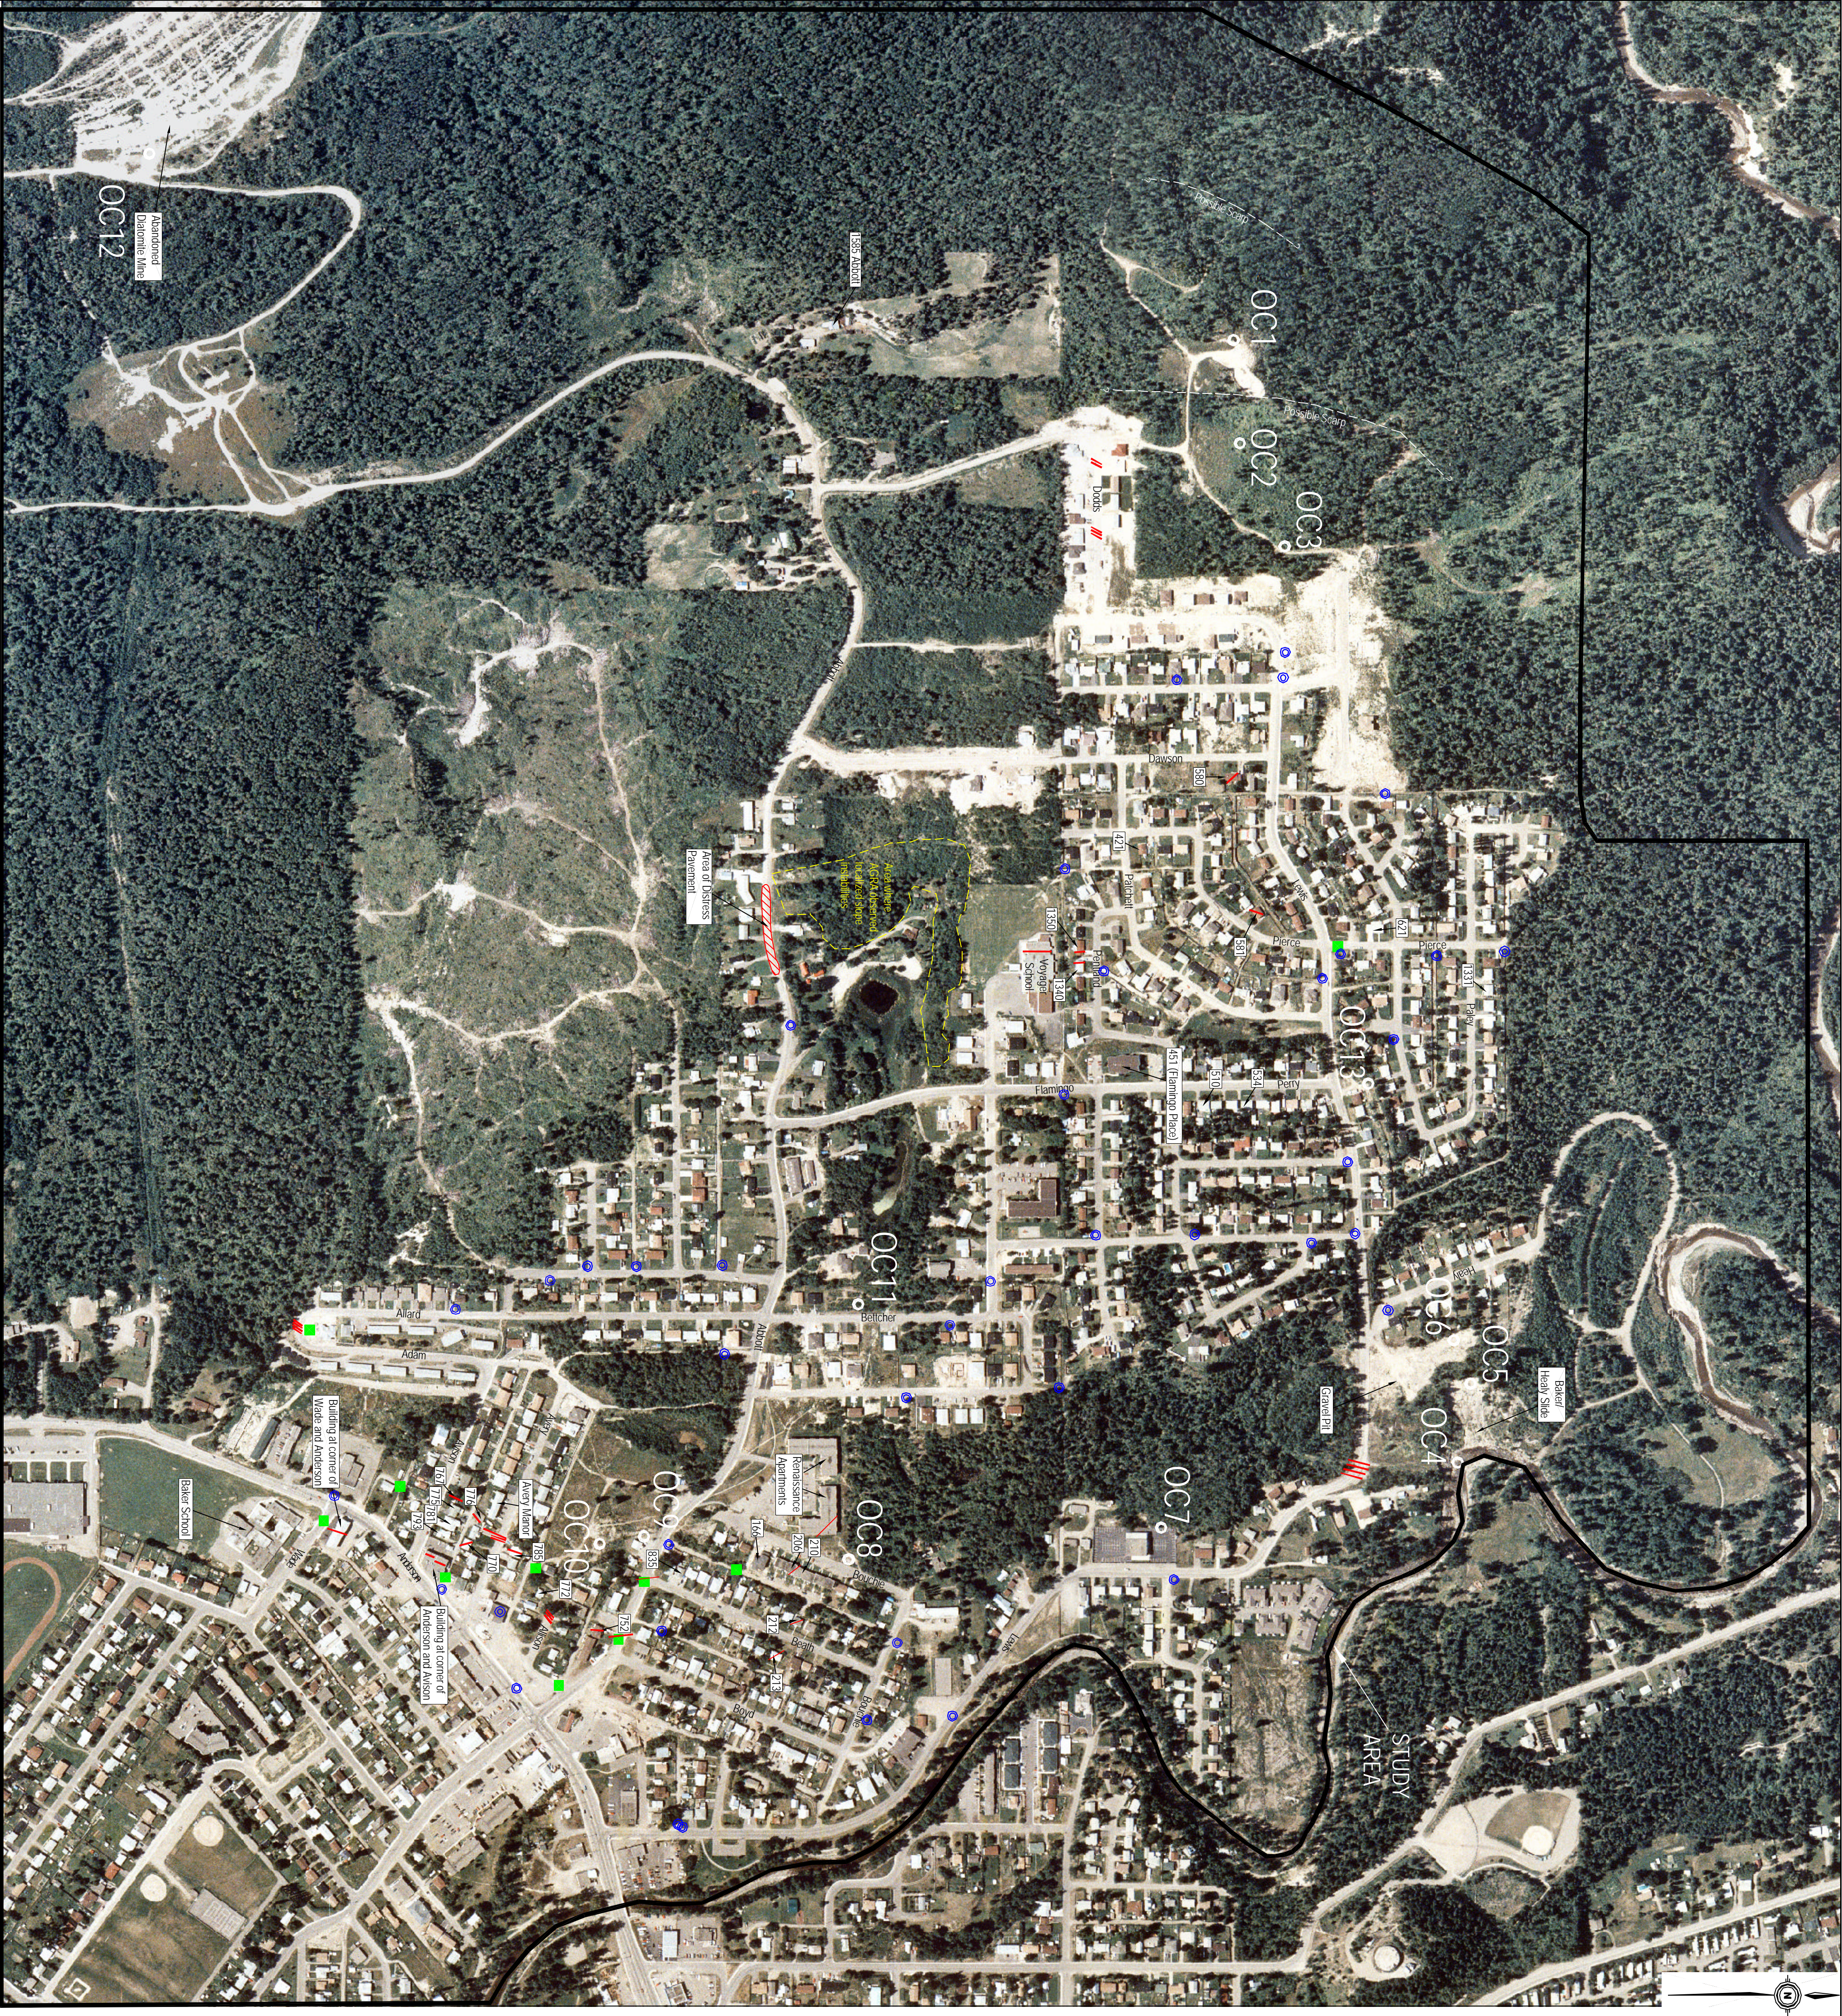
There have also been approximately 40 gas line service breaks reported by BC Gas. The locations of observed pavement distress, and reported water line and gas utility line breaks are shown on Figure 6.
