**Slope Stability Study Using LiDAR  
Imagery  
City of Quesnel and Surrounding Fringe  
Area**

**Cariboo Regional District**  
Suite D – 180 North 3<sup>rd</sup> Ave.  
Williams Lake, BC V2G 2A4  
Attention: John MacLean

July 1, 2022  
File No. 021-069

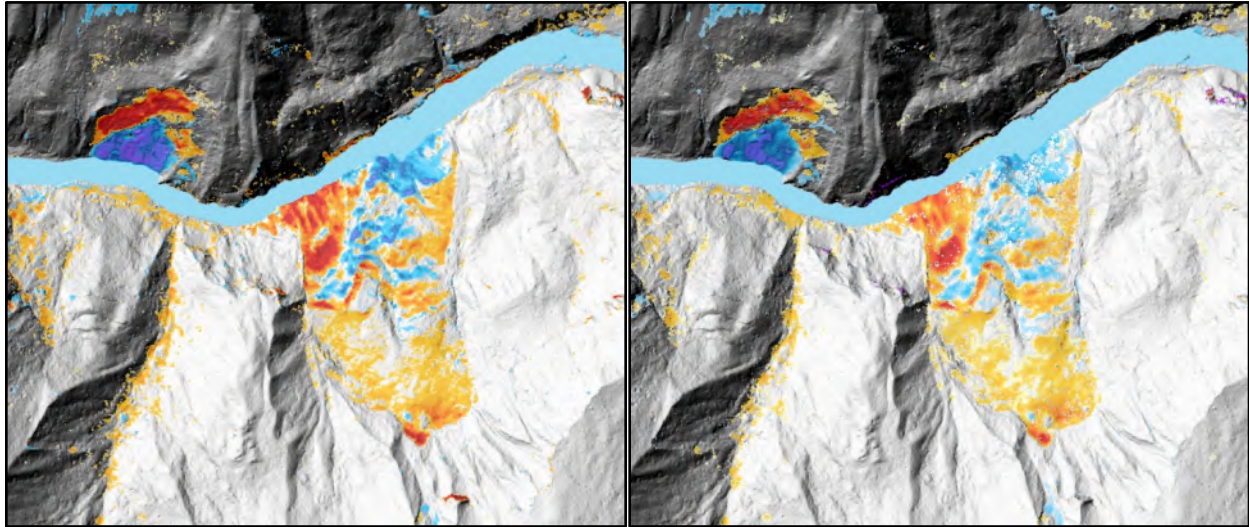
*Figure 3: An excerpt from the output using the DOD (on the left) and M3C2 methods (on the right).*

The model results were classified into 10 cm increments between -2 m and 2 m, and in 1 m increments beyond this range. Figure 3 depicts an output sample using both methods, and as noted:

- The yellow to red colours represent areas where the elevation change was negative, i.e., the elevation dropped between 2019 and 2021; and
- The light blue to purple colours represent areas where the elevation change was positive, i.e., the elevation increased between 2019 and 2021.

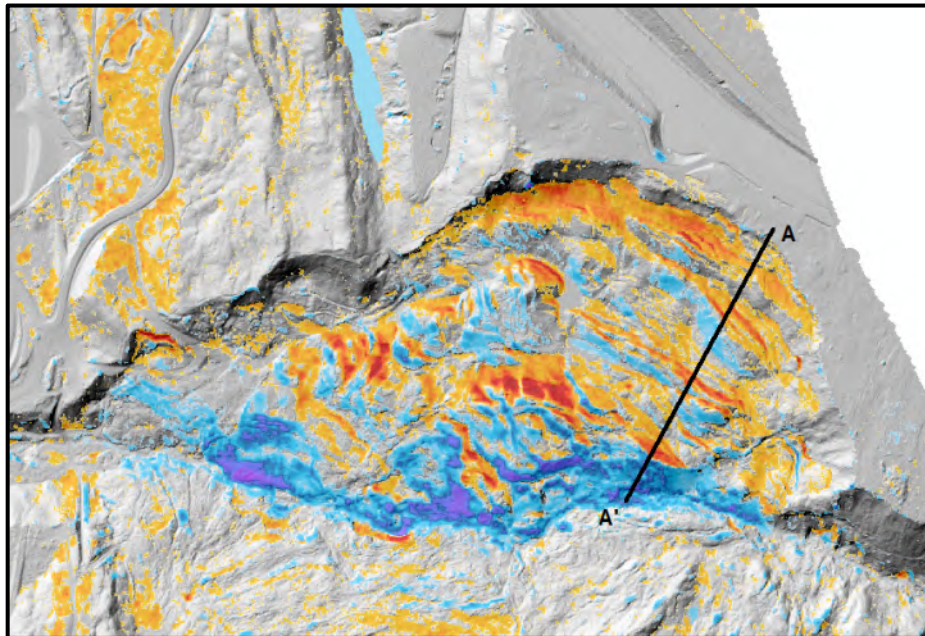
*Figure 4: Part of the recent slope movement next to Dragon Creek, showing the transverse ridges and troughs from the change detection analysis, which delineate the slope movement from 2019 to 2021.*

Some of the landslide/slope movements observed on the change detection output contained transverse ridges and troughs (Figure 4). A translational shift perpendicular to the ridges (i.e., generally down the fall-line) appears as alternating bands of negative and positive vertical change. The leading edge of the ridge will appear to have gained elevation, while the trailing edge will appear to have lost elevation.

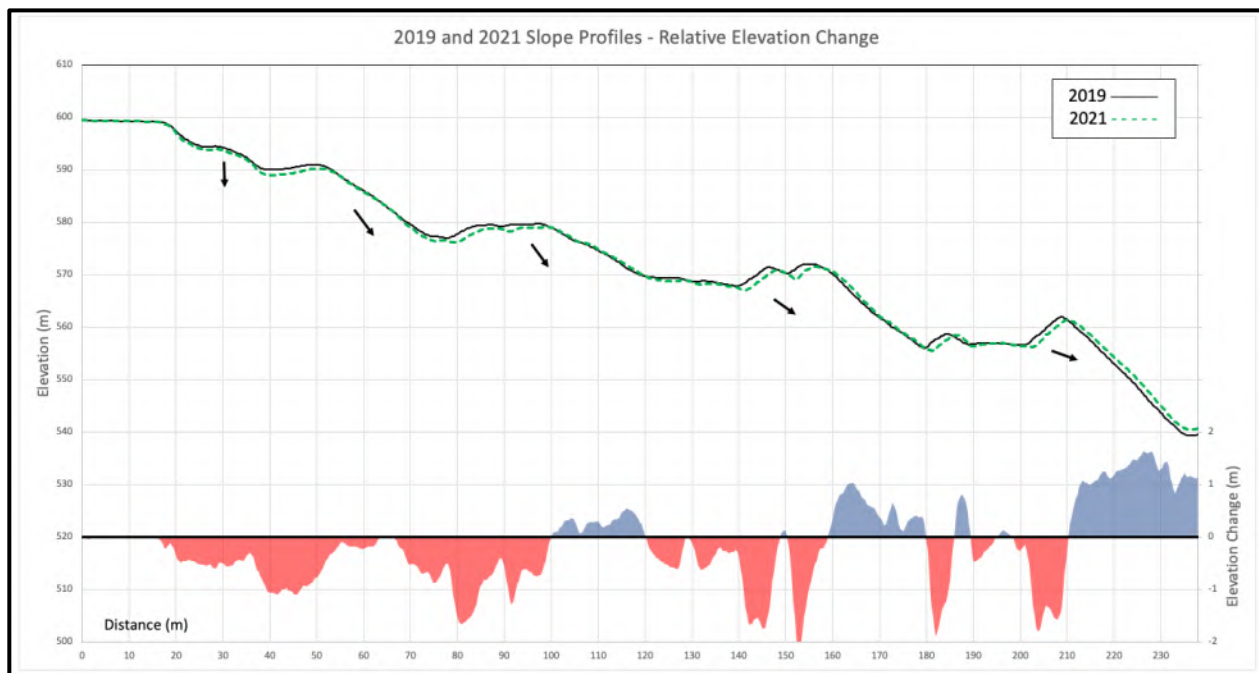
*Figure 5: The slope profile along the slope traverse from A to A' showing the slope movement from 2019 to 2021, both horizontally and vertically.*

The slope profile (Figure 5) generated along line A-A' (Figure 4) illustrates this by showing the relative elevation changes in red (negative) and blue (positive). The black arrows depict the probable overall displacement direction, i.e., the slope movement was from A to A'.

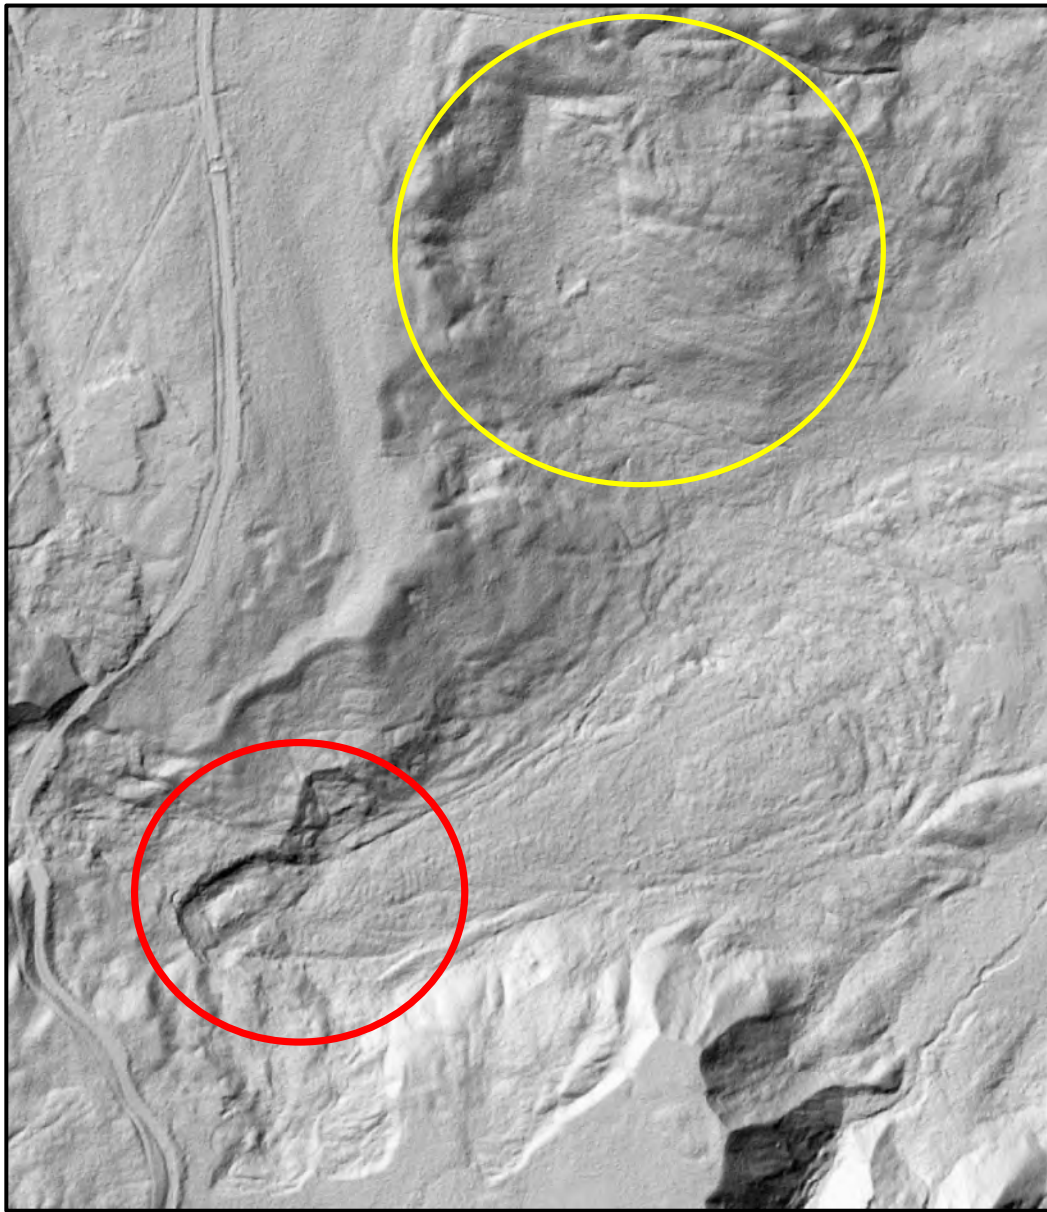
*Figure 17: An excerpt from the 2019 LiDAR bare earth image showing the distinct slope morphology from an example of actively unstable slopes (the red circle) and the more subdued morphology from an example of potentially unstable slopes (the yellow circle).*

Older slope movement (i.e., ancient) and potentially unstable slopes, where the slope movement either may not be as clear, may have either been smoothed over, or have some characteristics of slope movement (Figure 17), may not be as clear to identify.

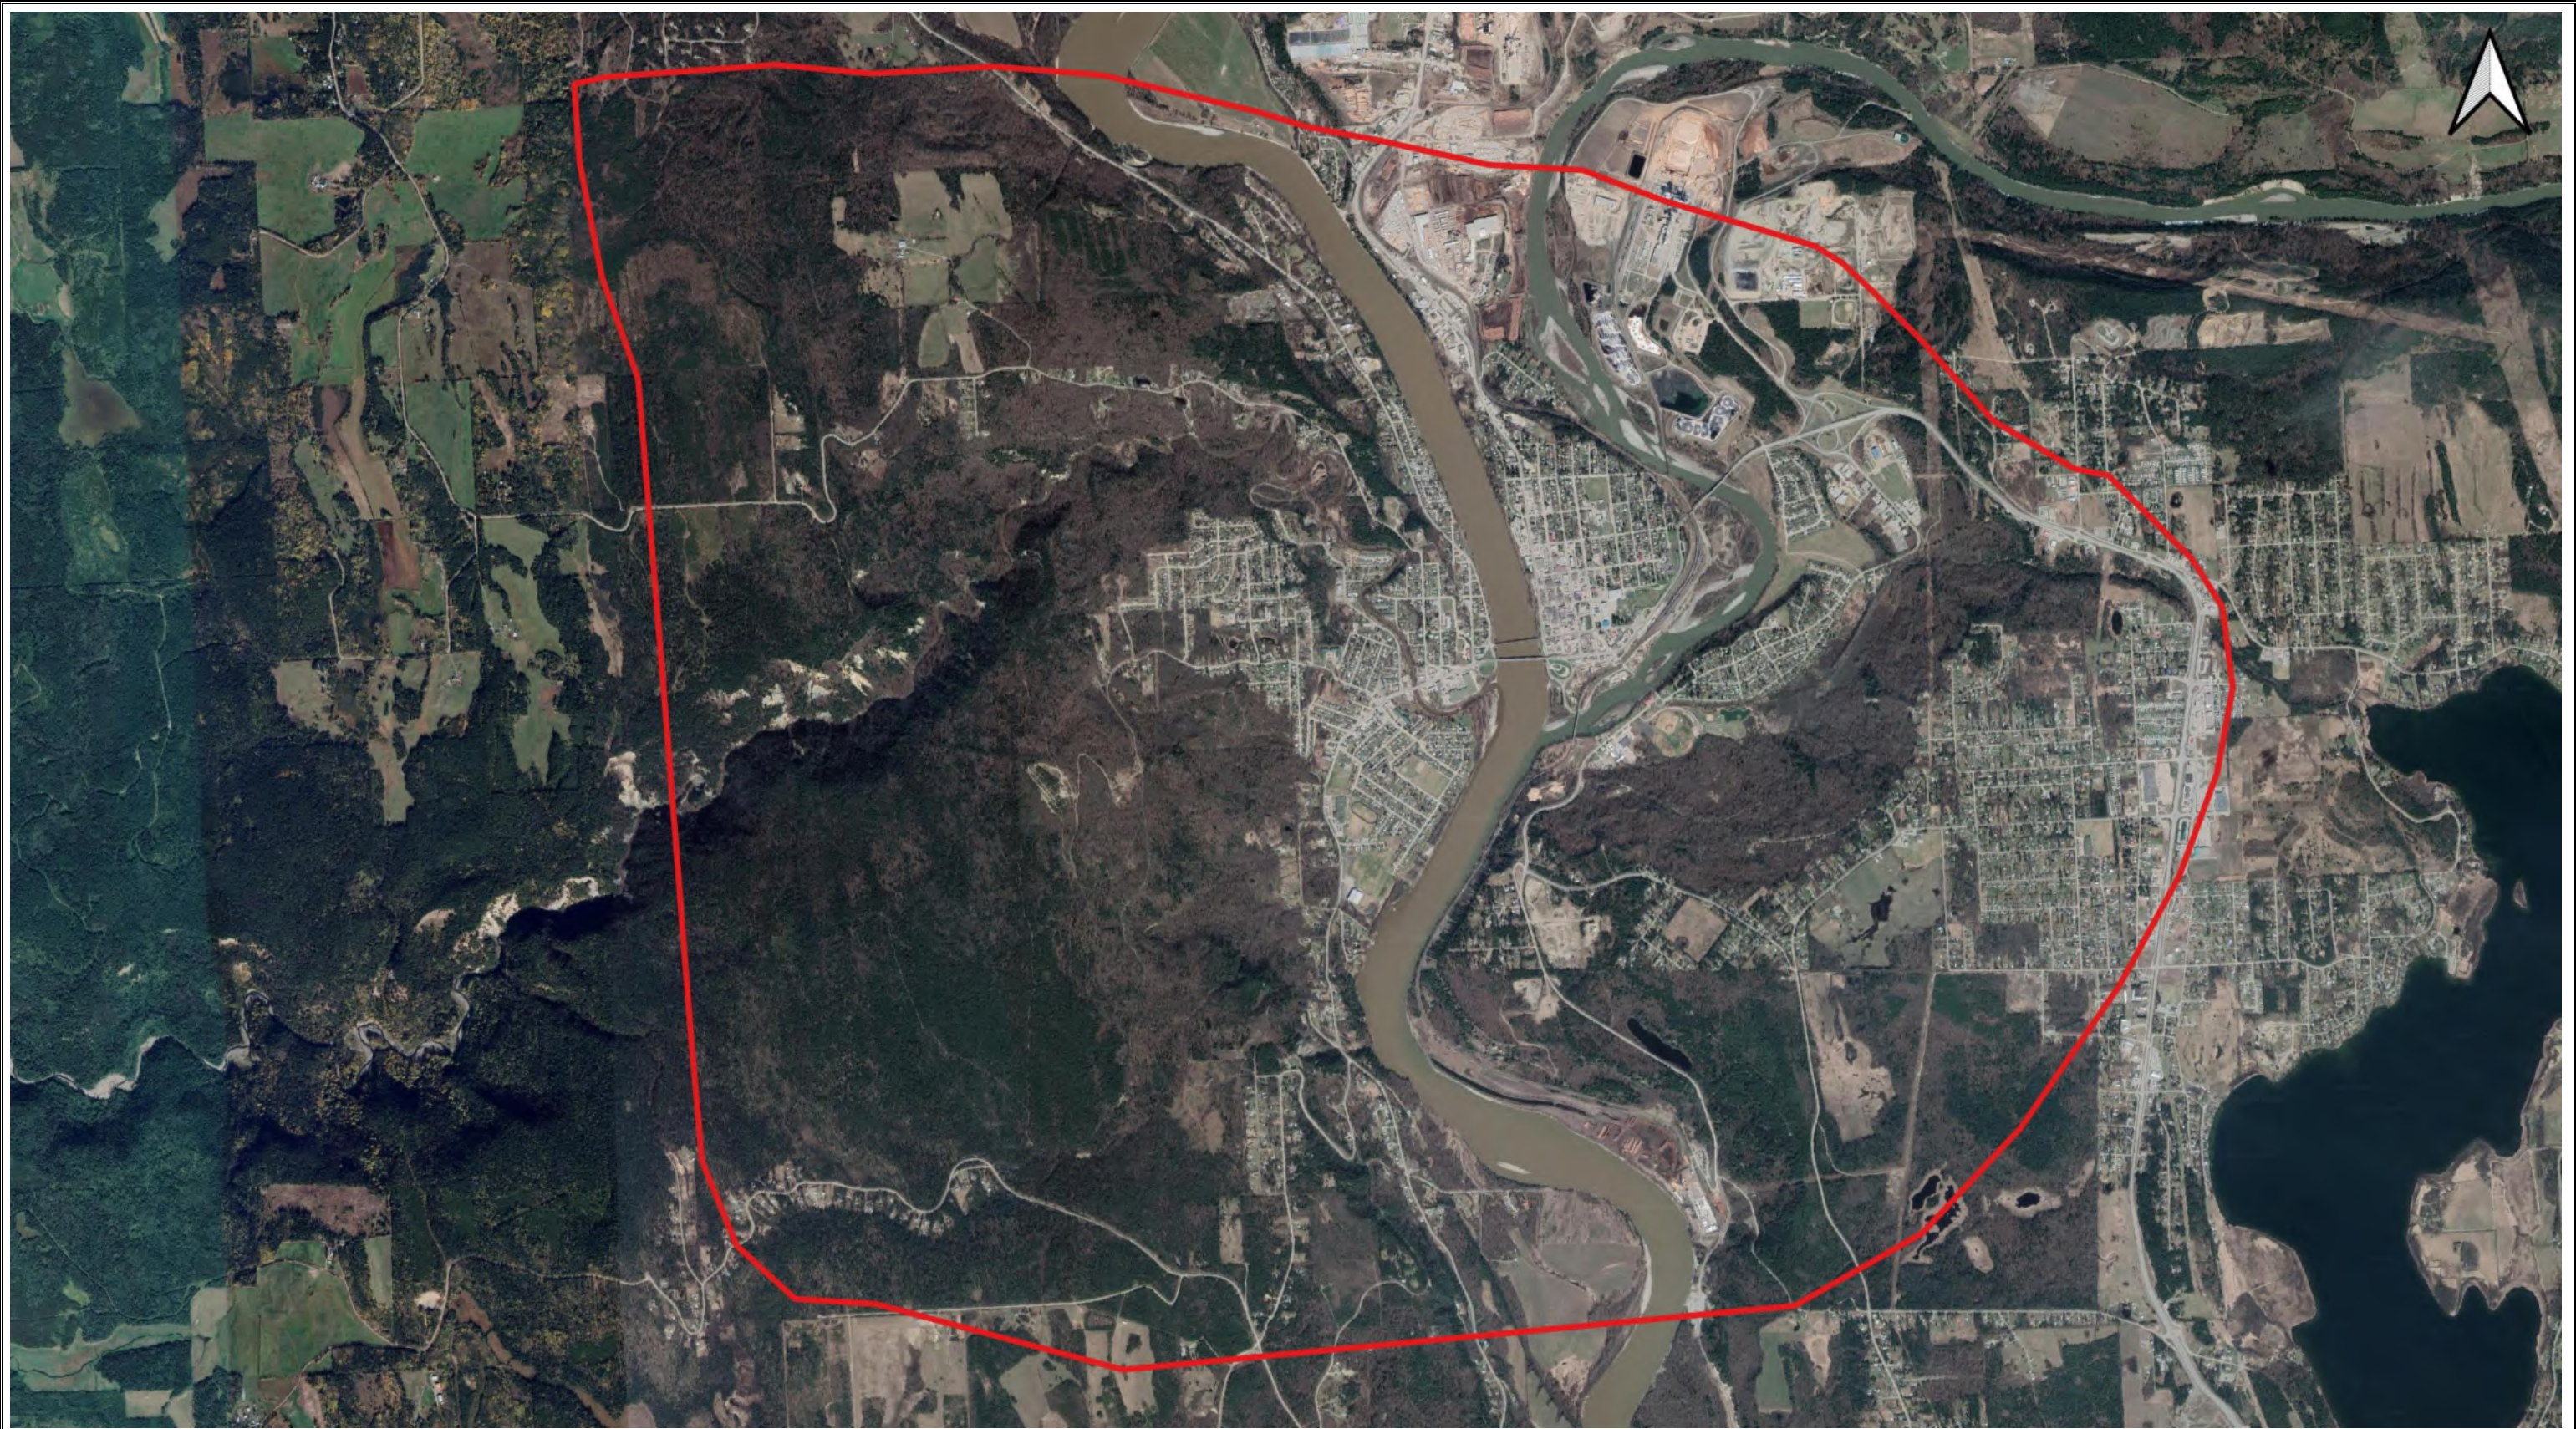
**FIGURE 2**

**The Study Area Extent for the Change Detection Analysis using the 2019 and 2021 LiDAR Datasets.**

The study area for the change detection analysis in Quesnel and the surrounding fringe areas is approximately 59 km<sup>2</sup> (Figure 2) while the overall unstable/potentially unstable slopes identification study area is 278 km<sup>2</sup> (Figure 1). Two LiDAR datasets were used for this analysis; the 2019 imagery referred to as the baseline dataset, and the 2021 imagery, referred to as the active dataset. The data for both sets was provided as LAS point clouds.
