# **Request for Proposals (Extended) 505 Panorama Ridge Demolition and Remediation.**

# Pre-Demolition Hazardous Materials Survey Report

505 Panorama Ridge, Quesnel, BC

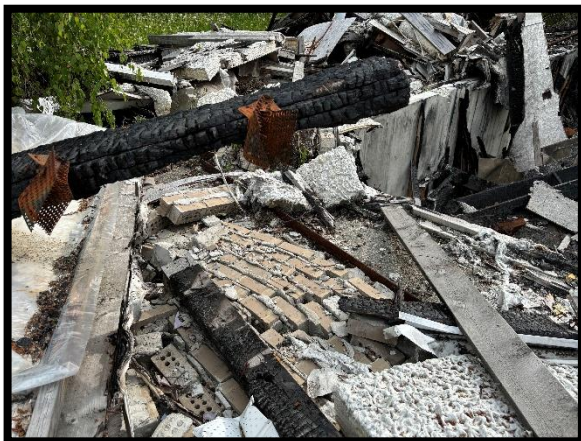
Asbestos was not identified within the brick mortar (S03) applied to bricks and present as debris within the Debris Pile (Loc. 1).

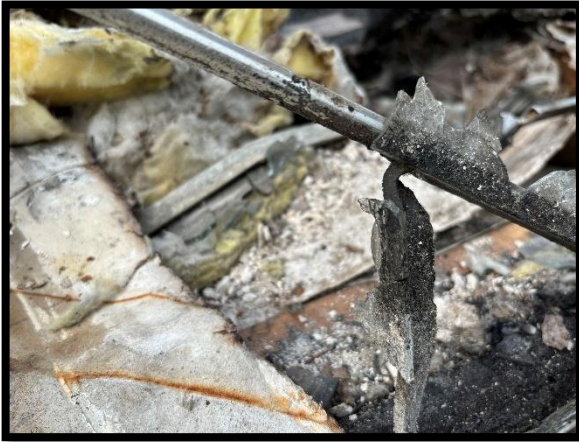
Asbestos was identified within the grey window mastic (S04) applied to windows within the Debris Pile (Loc. 1).

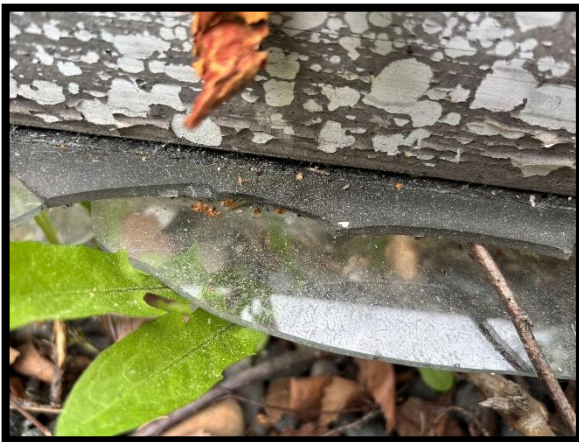
Asbestos was identified within the black window mastic (S05) applied to windows within the Debris Pile (Loc. 1).

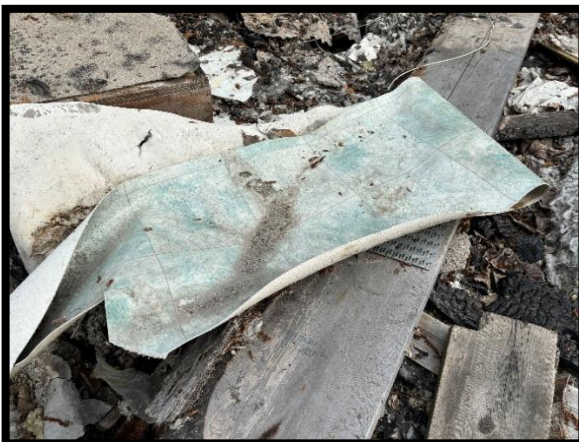
Asbestos was not identified within the blue and white pattern vinyl sheet flooring (S06) present as debris within the Debris Pile (Loc. 1).
